Eddy Current NDT Pulsed Thermography Simulation for Defect Detection

Eddy current pulsed thermography ECPT

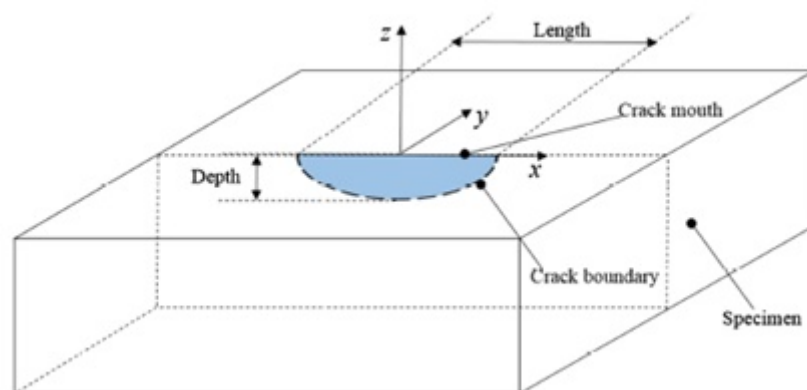
The figure below depicts the semi-elliptical crack shape, while Table 1 provides detailed dimensions of each component.

Figure 2 - Geometry of the tested plate containing a semi-elliptical surface-breaking crack [1]

Part	Dimensions		
Coil	Turns: 3	Main diameter: 25 mm	Wire diameter: 6.35 mm
Outer dimensions of the ferrite yoke	Length:58.5 mm	Width:43 mm	Height:27.5 mm
Inner dimensions of the ferrite yoke	Length:56.1 mm	Width:31 mm	Height:27.5 mm
Specimen	Length: 130 mm	Width: 65 mm	Height: 7.5 mm
Semi-elliptical crack	Length: 12 mm	Width: 0.6 mm	Depth: 2.4 mm
Gap between yoke and specimen	1mm

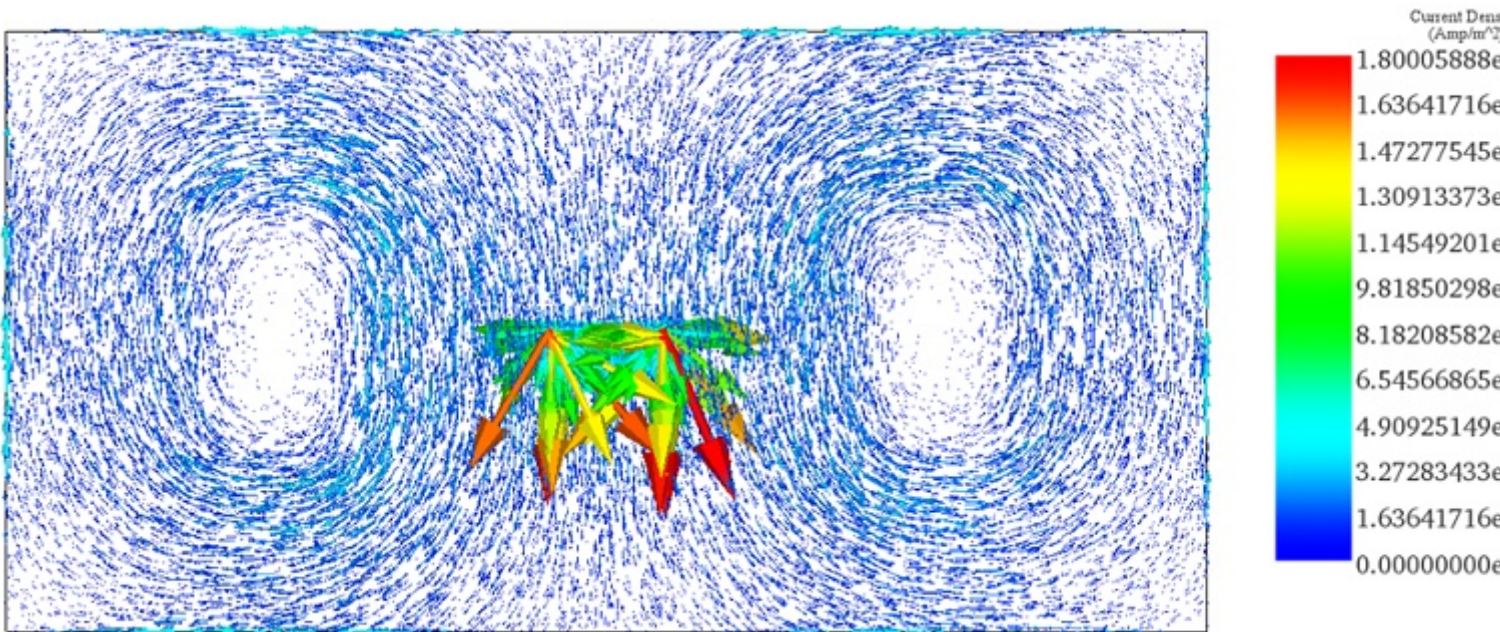
After 500 ms of induction heating, the simulation revealed significant findings. The current density distribution around the crack on the specimen surface displayed a clear perturbation of eddy currents, reaching maximum intensity around the endpoints of the detected defect. The altered flow directions of currents induced by the crack resulted in uneven heating of the surface.

Figure 4 - Vector plot of current density distribution

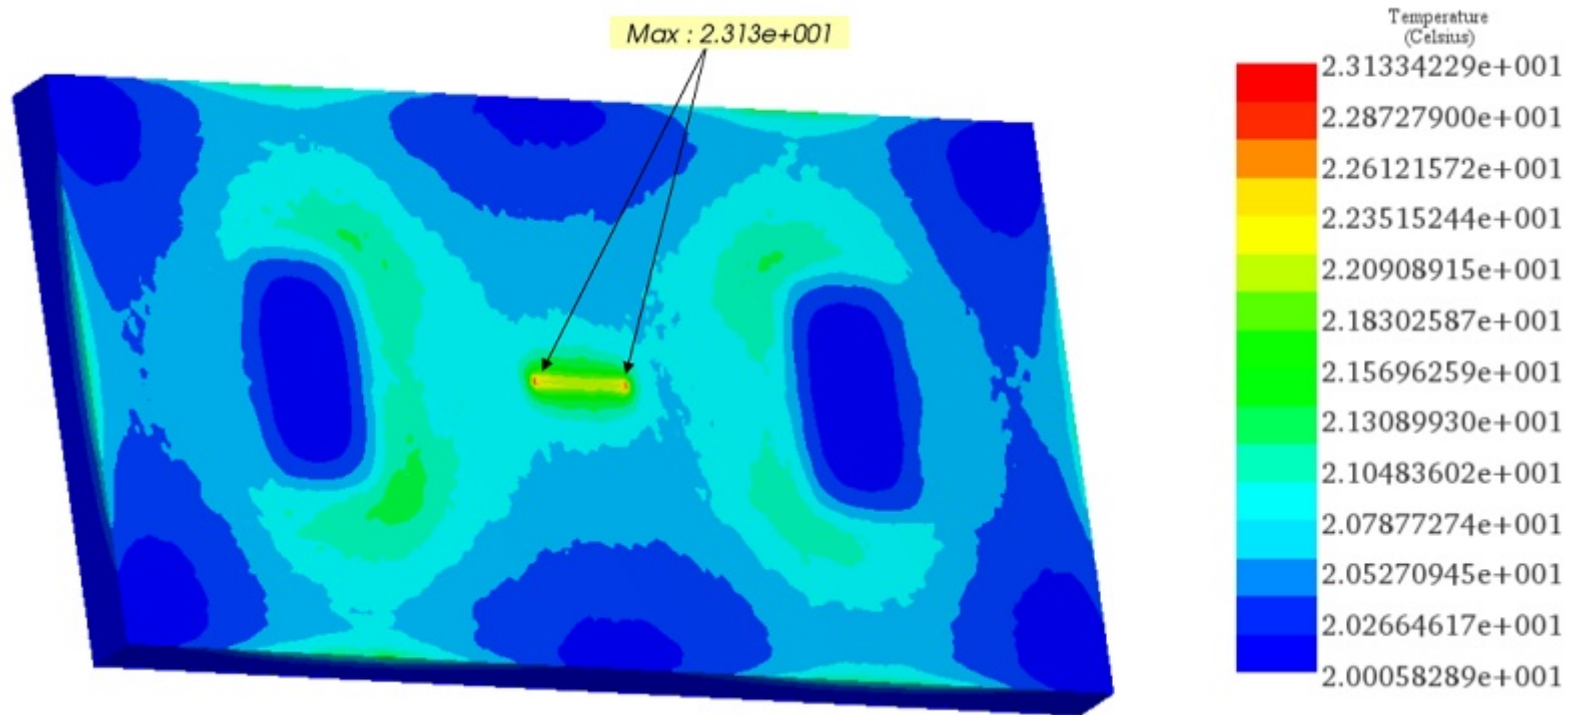
The induced temperature distribution is depicted in Figure 5. Across the central region of the U-shaped core on the specimen, the temperature appears to be evenly distributed. The maximum temperature is observed at the contours of the crack, reaching 23.13 °C, aligning well with the results reported in Reference [1].

Figure 5 - Temperature distribution

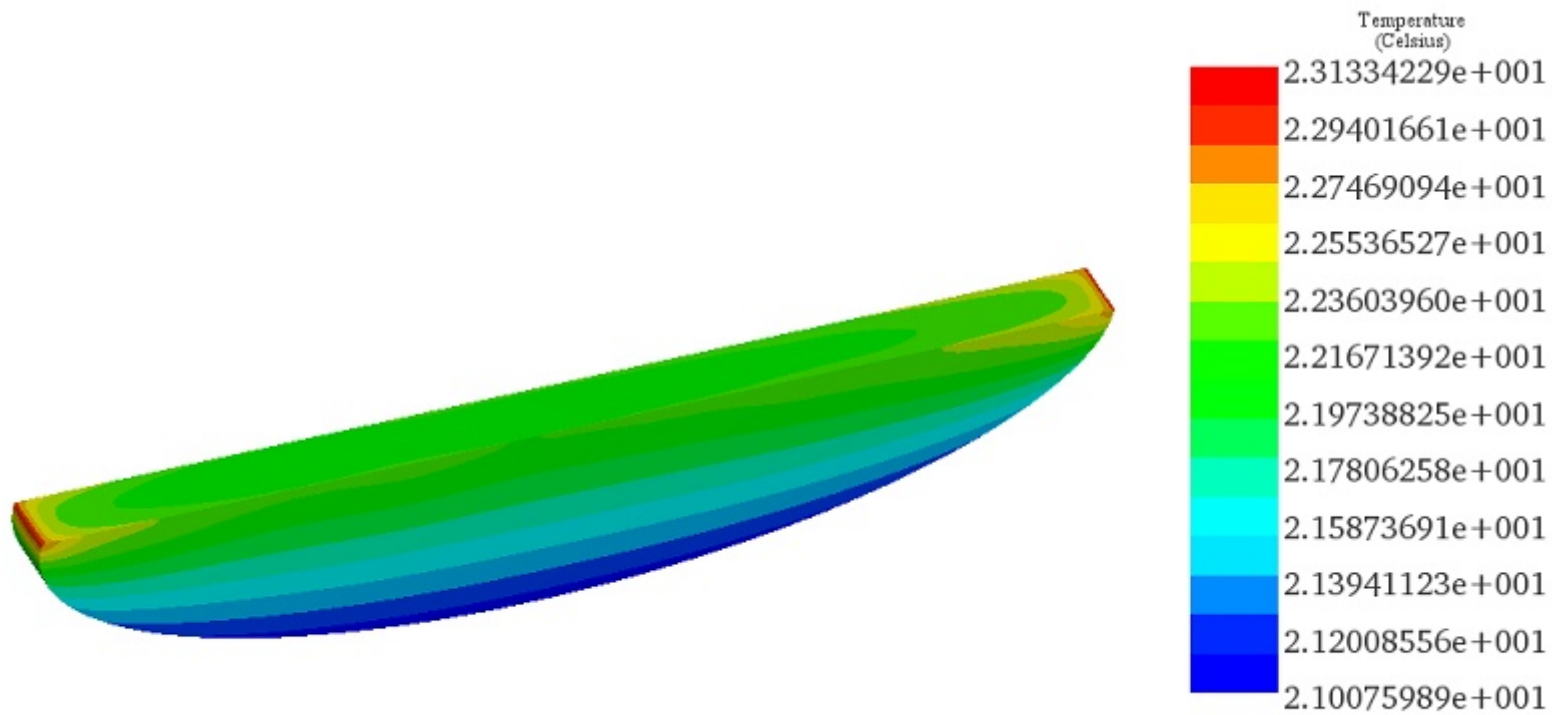
Figure 6 illustrates the region of heated air delimited by the crack. Noticeably, the temperature at the endpoints of the defect surpasses that of other areas, sharply declining in the depth direction. These distinct characteristics aid in predicting the crack length from the two peak temperature points at the edges and determining the temperature difference between the crack and other regions.

Figure 6 - Temperature distribution across the crack.
